Your Inspection Report

1234 Maple Rd.
My Town, OK

David Dillingham, OK LIC # 70002591

RE: Report No. 1008
1234 Maple Rd.
My Town, OK

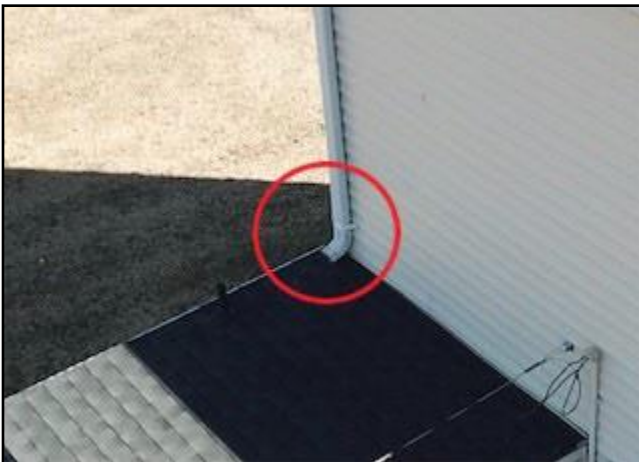
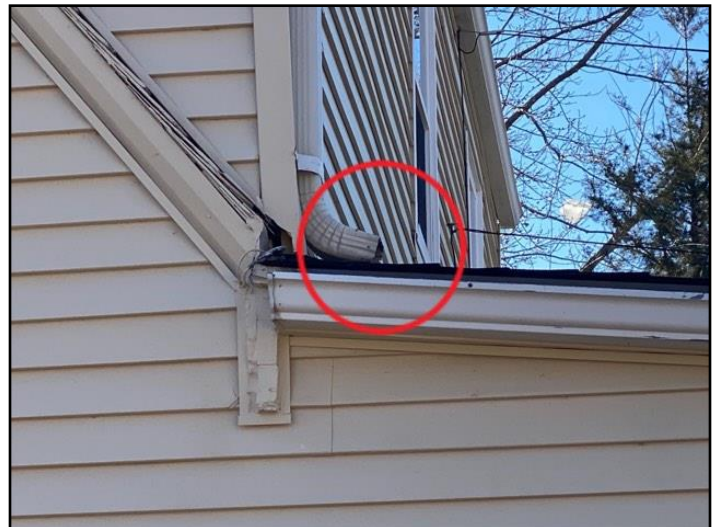
4. Condition: • Missing downspout

A downspout was missing at the time of the inspection. The Inspector recommends replacement to help protect the homes structure. All work should be performed by a qualified contractor.

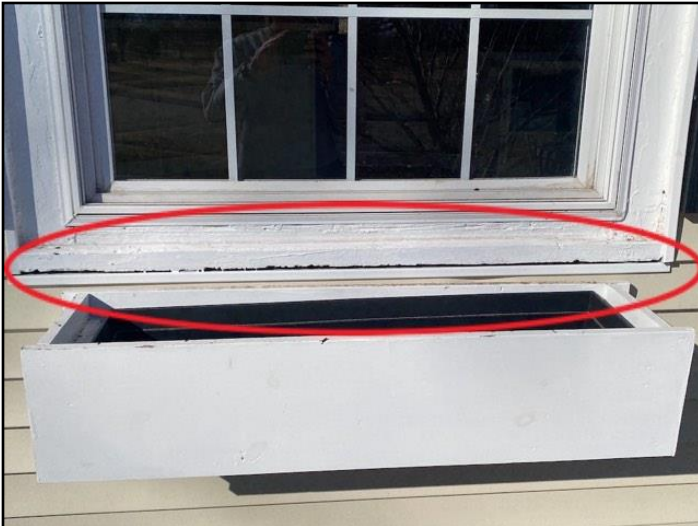
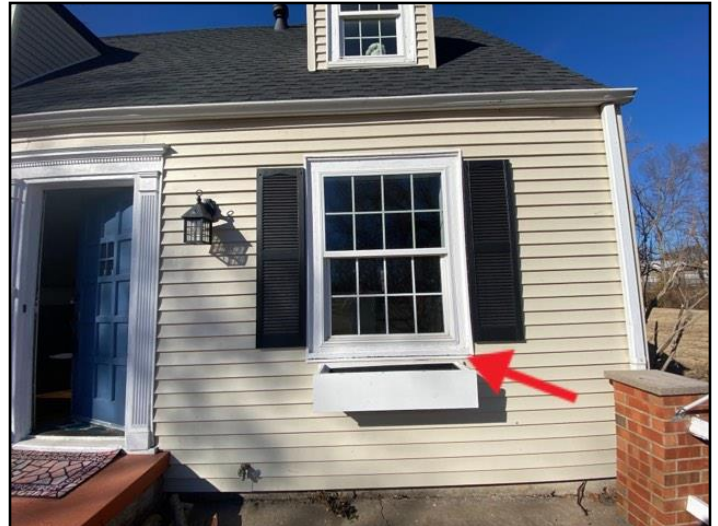
5. Condition: • Paint and Caulking - deteriorated / missing

Paint and Caulking - deteriorated / missing

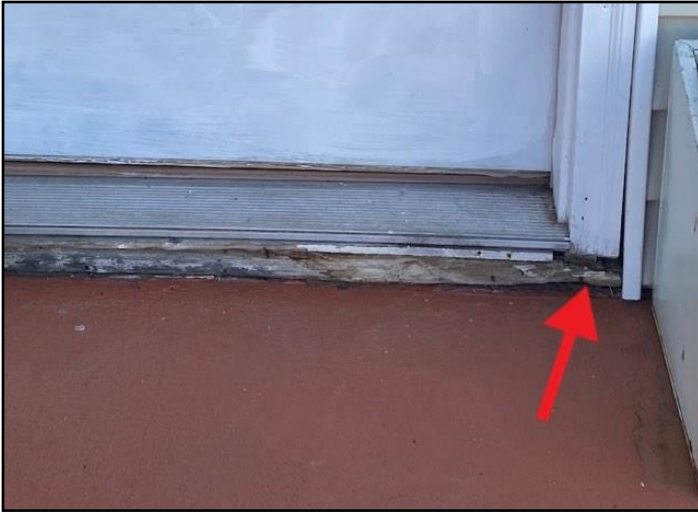
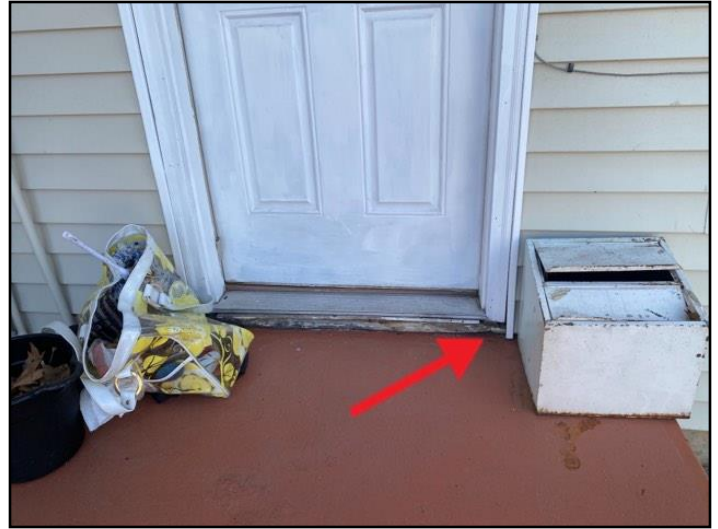
6. Condition: • Threshold damaged

The threshold of the exterior door at the rear of the house was damaged or deteriorated. Recommend replacement by a qualified contractor.

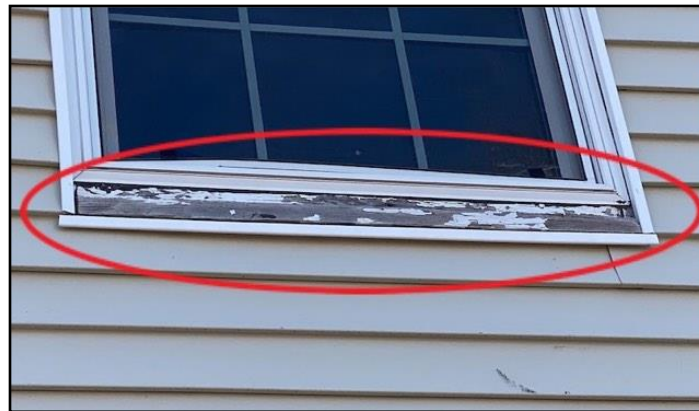
7. Condition: • Window sill deteriorated/damaged

Components of window sill exteriors were loose, damaged or deteriorated and needed maintenance at the time of the inspection to help prevent damage from moisture intrusion to the home materials, the exterior wall structure and to prevent development of microbial growth such as mold. All work should be performed by a qualified contractor.

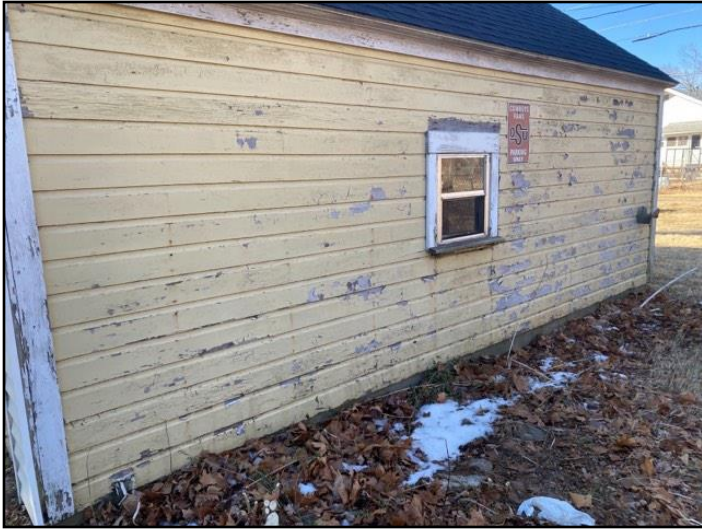
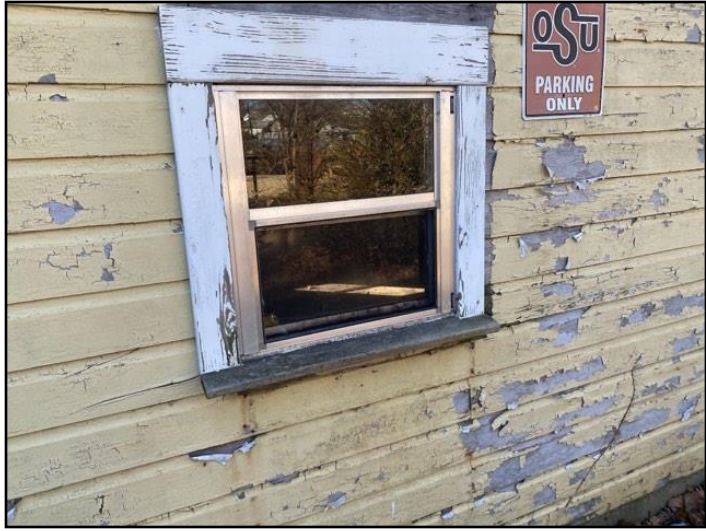
8. Condition: • The exterior walls exhibited weathering, wear, and deterioration of exterior paint.

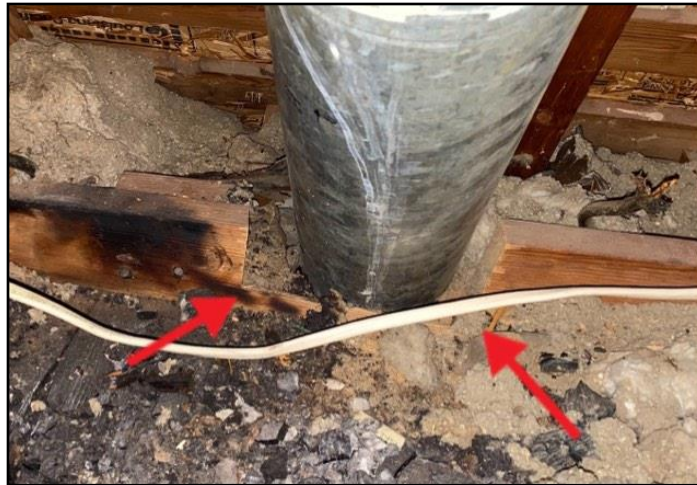
9. Condition: • Cut rafter

Observed a cut rafter to allow access for duct. Cut rafters should be replaced or braced in a way that can adequately distribute weight. Recommend further evaluation by a qualified contractor.

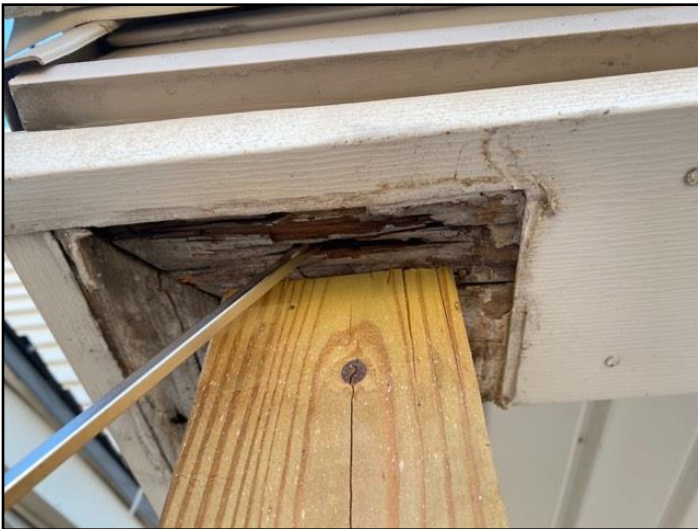
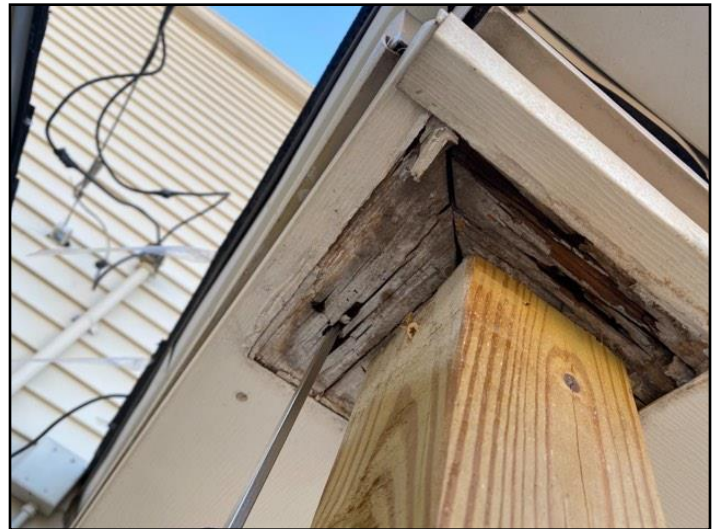
10. Condition: • Ceiling of patio cover exhibited rot.
Recommend necessary repairs done by a qualified contractor.

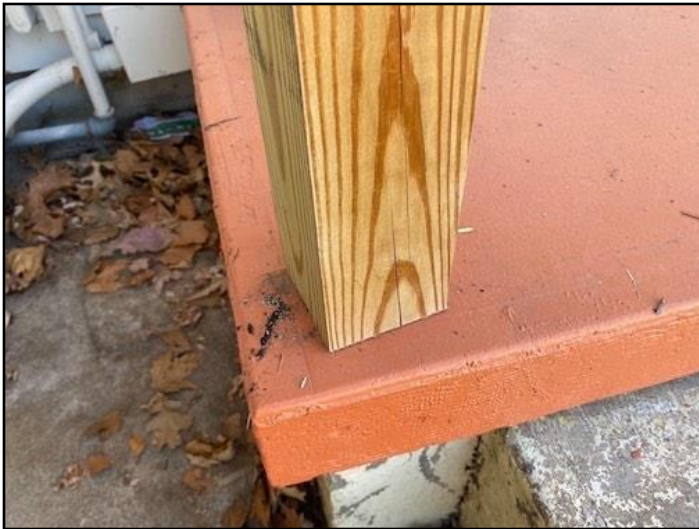
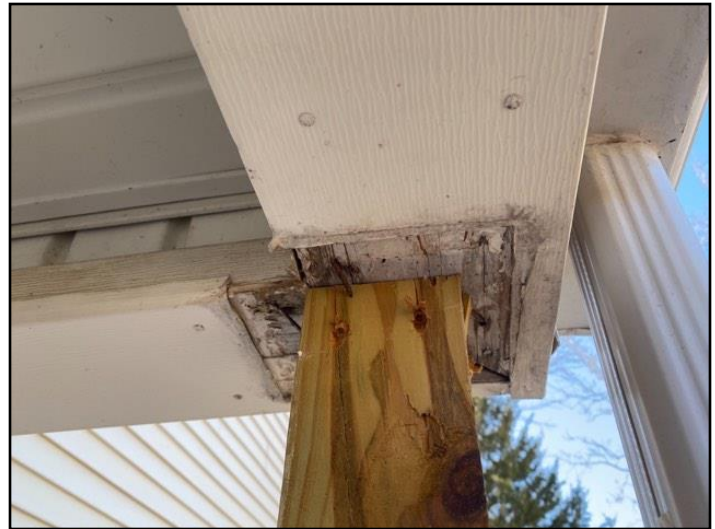
11. Condition: • Poorly secured at top or bottom

Both post on rear patio were not properly attached. Recommend installation of proper hardware (column cap and column base) by a qualified contractor.

Implication(s): Weakened structure | Chance of structural movement

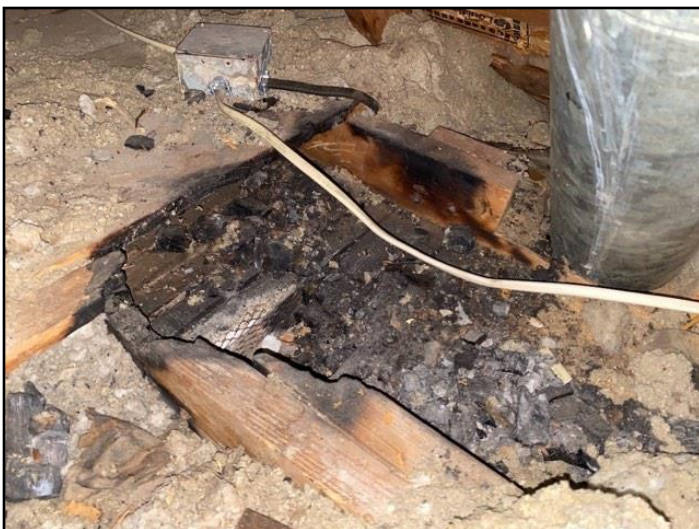
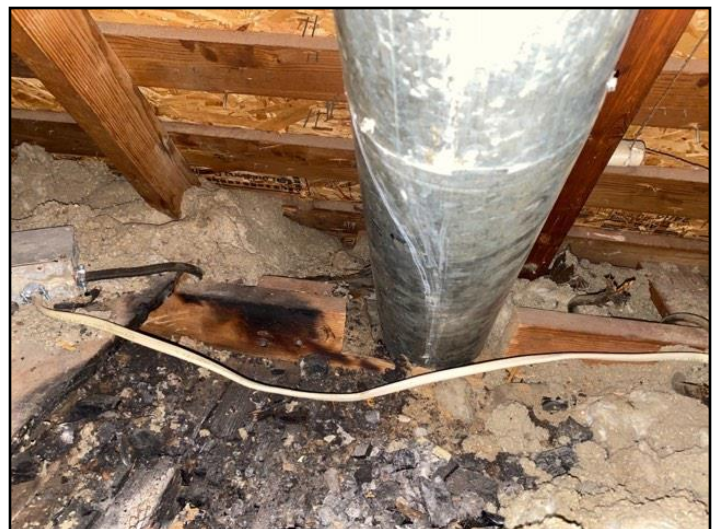
12. Condition: • [Fire damage](#)

Fire damage was observed in the attic at the time of the inspection. Cause of fire is beyond the scope of this inspection. Recommend evaluation and repairs done by a qualified contractor.

Fire damage

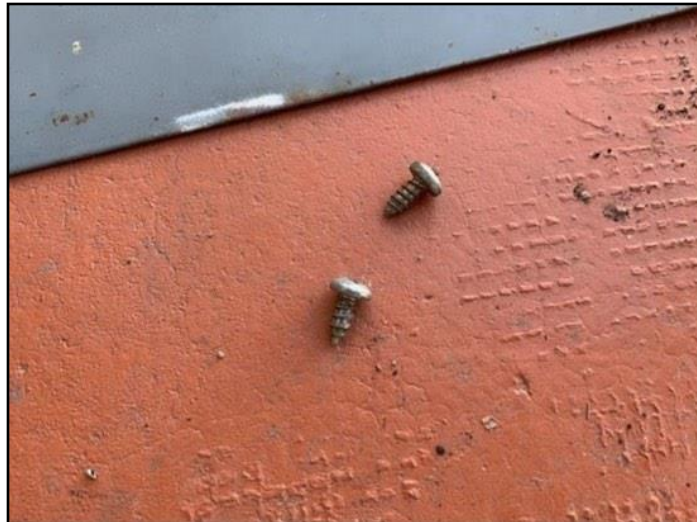
13. Condition: • Improper screws

Observed the use of improper screws for dead front cover. Must be secured with blunt tips and fine threads. Sharp tipped, coarse threaded screws can cut through insulation, causing dangerous arc flashes. Recommend correction.

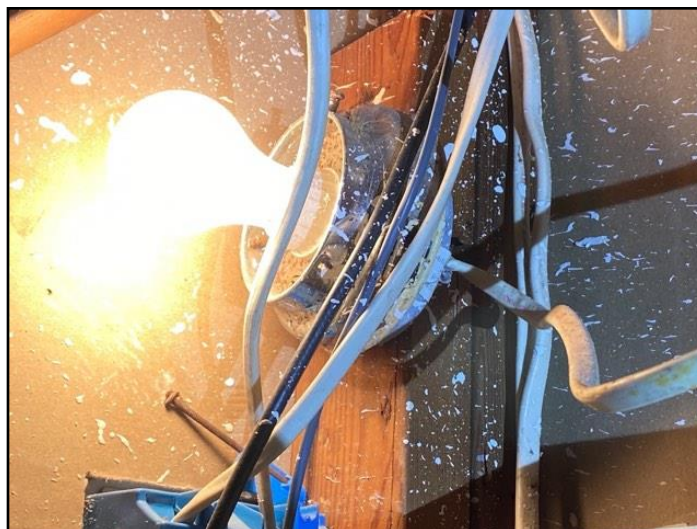
14. Condition: • Poor wire installation

Observed wires under stairs near or touching light bulb, which could melt wiring. Recommend further evaluation by a qualified electrical contractor.

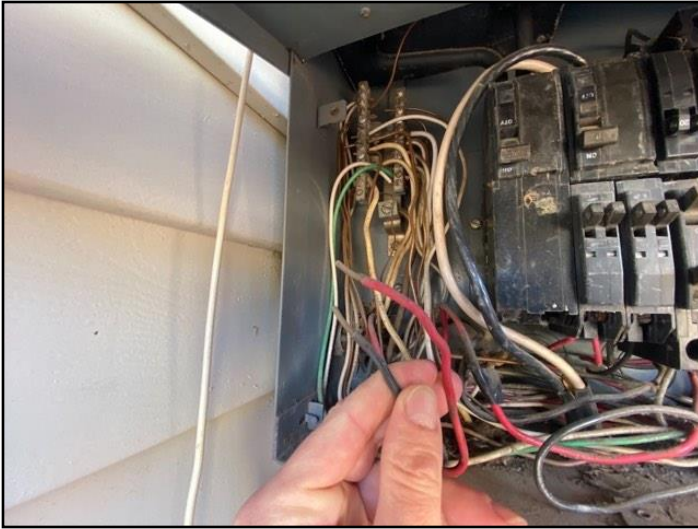
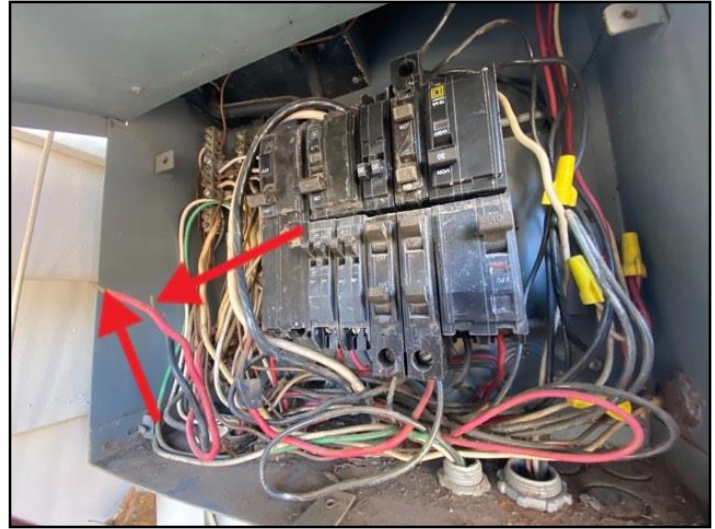
15. Condition: • Exposed wires

Exposed wires were observed in the service panel. Recommend correction by a qualified electrical contractor.

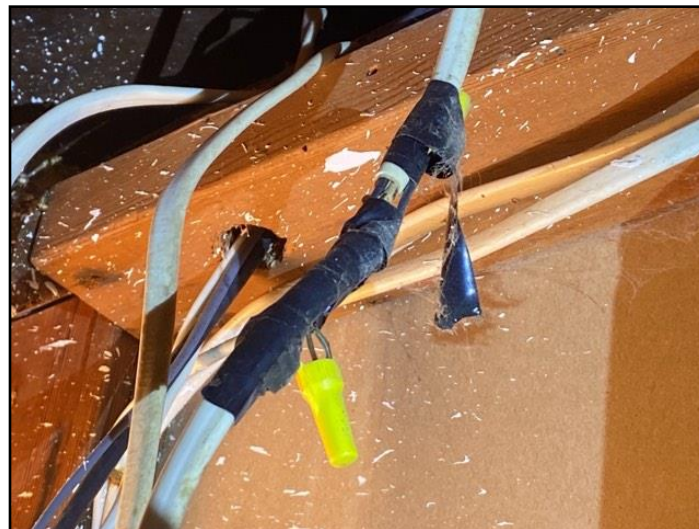
16. Condition: • [Damage](#)

Observed wiring beneath stairs that had been repaired with tape. This is an improper repair and should be corrected by a qualified electrical contractor to help ensure that safe conditions exist.

Implication(s): Electric shock | Fire hazard

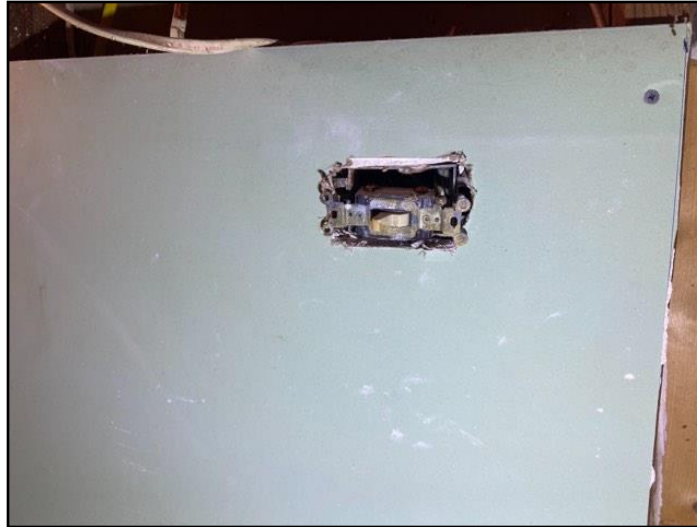
17. Condition: • For switch is missing

At the time of the inspection, a switch cover plate was missing in the basement beneath the stairs. This condition left energized electrical components exposed to touch, a shock/electrocution hazard. Recommend that a listed cover plate be installed by a qualified electrical contractor.

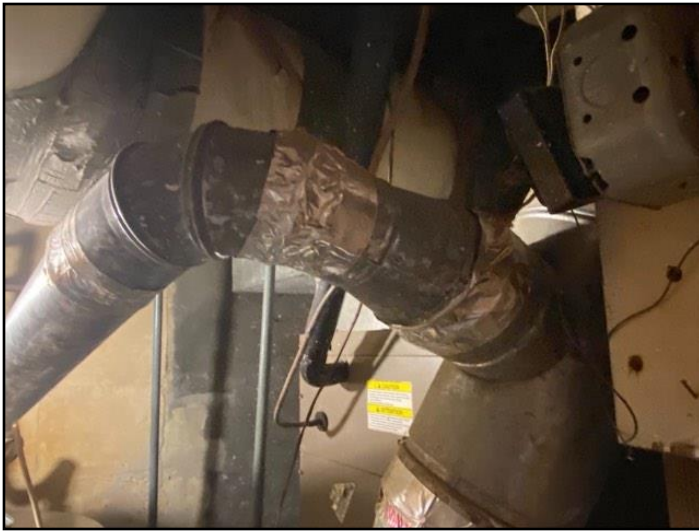
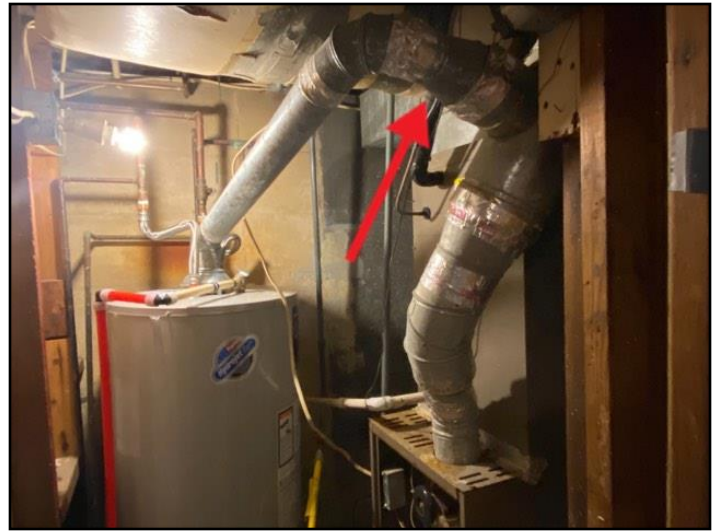
20. Condition: • Vent poorly sloped

The vent connector designed to exhaust the products of combustion from the furnace gas burner was inadequately sloped. Vent connectors should slope upward away from the furnace a minimum of 1/4-inch per foot. Inadequate slope can result in backdrafting. "Backdrafting" is a condition in which the products of combustion from the furnace gas burner fail to exhaust to the home exterior, but are pulled from the flue into the living space. Excessive exposure to these products of combustion can result in injury or death. Recommend correction by a qualified HVAC contractor.

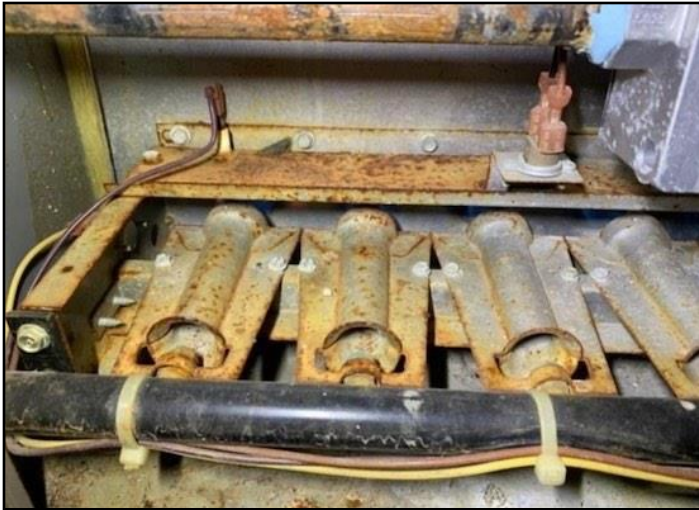
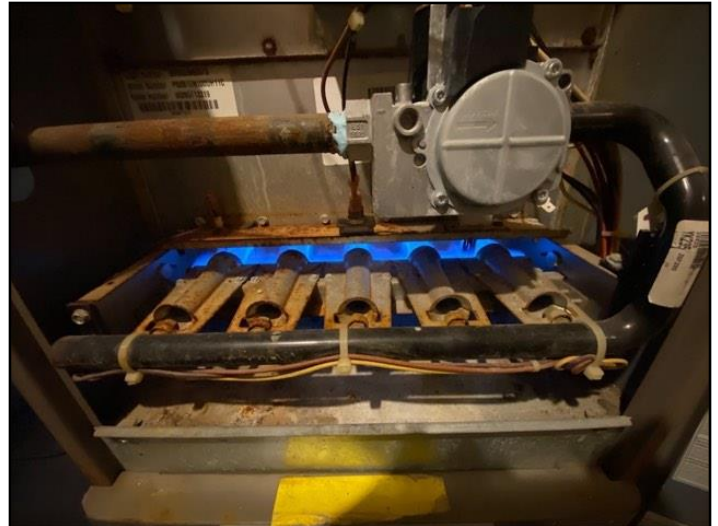
21. Condition: • Rust

Rust was observed on the gas burners at the time of inspection. Recommend further evaluation by a qualified HVAC contractor.

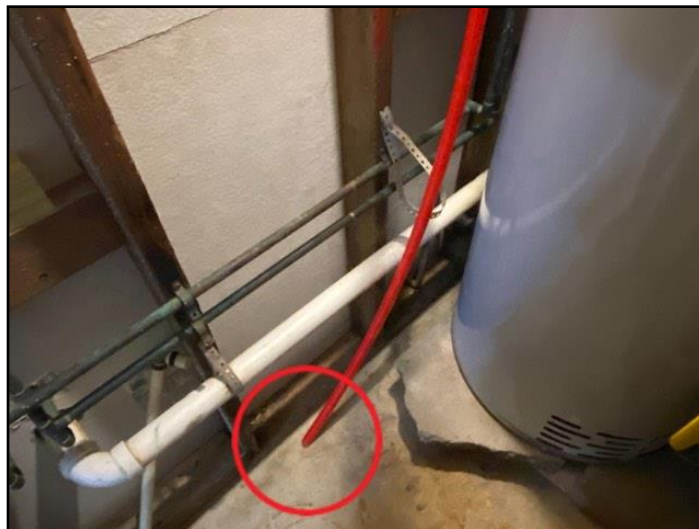
23. Condition: • Improper termination

TPR discharge tube extended to the floor. This may cause the water flow to be restricted if pressure relief valve is engaged. Pipe should terminate within 6 inches of floor and no more than 2 feet above floor. Recommend correction.
