Your Inspection Report

1234 Maple Rd.
My Town, OK

David Dillingham, OK LIC # 70002591

RE: Report No. 1008
1234 Maple Rd.
My Town, OK

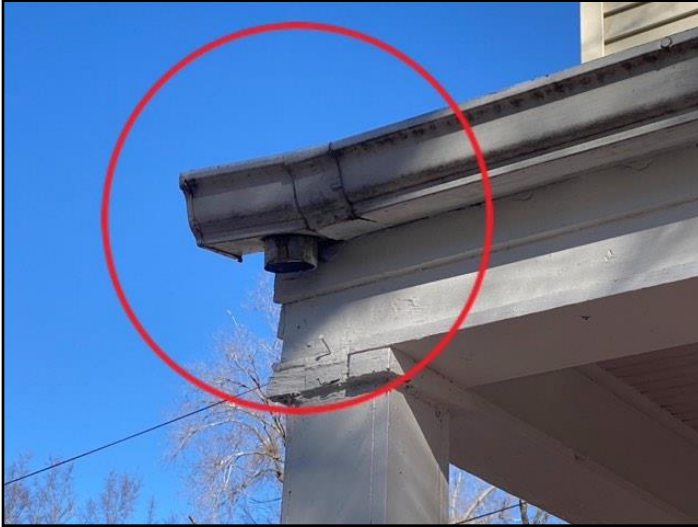
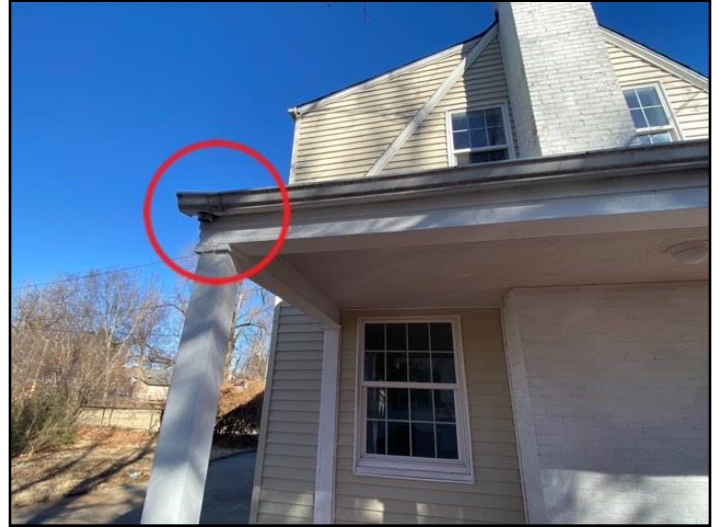
5. Condition: • Paint and Caulking - deteriorated / missing

Task: Repair

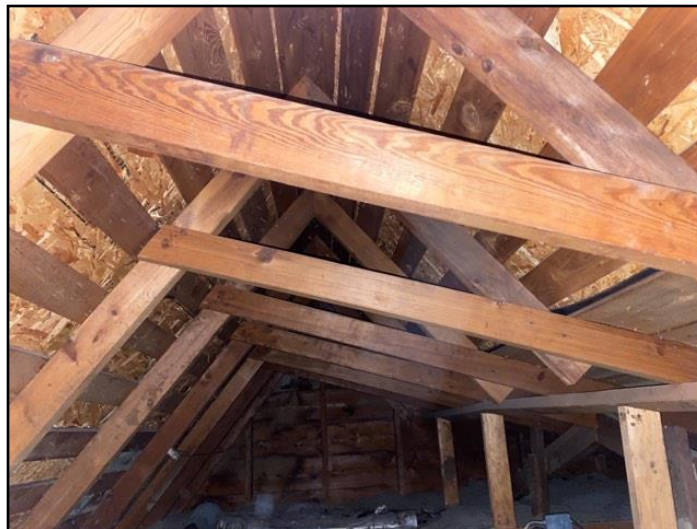
Rafters

Condition: • Cut rafter

Observed a cut rafter to allow access for duct. Cut rafters should be replaced or braced in a way that can adequately distribute weight. Recommend further evaluation by a qualified contractor.
